UNITED STATES  
DEPARTMENT OF THE INTERIOR  
BUREAU OF MINES  
DISTRICT H

REPORT OF FATAL BUMP ACCIDENT  
SUNNYSIDE NO. 2 MINE  
KAISER STEEL CORPORATION  
SUNNYSIDE, CARBON COUNTY, UTAH

January 29, 1959

Joe Freeman  
Coal-Mine Inspector

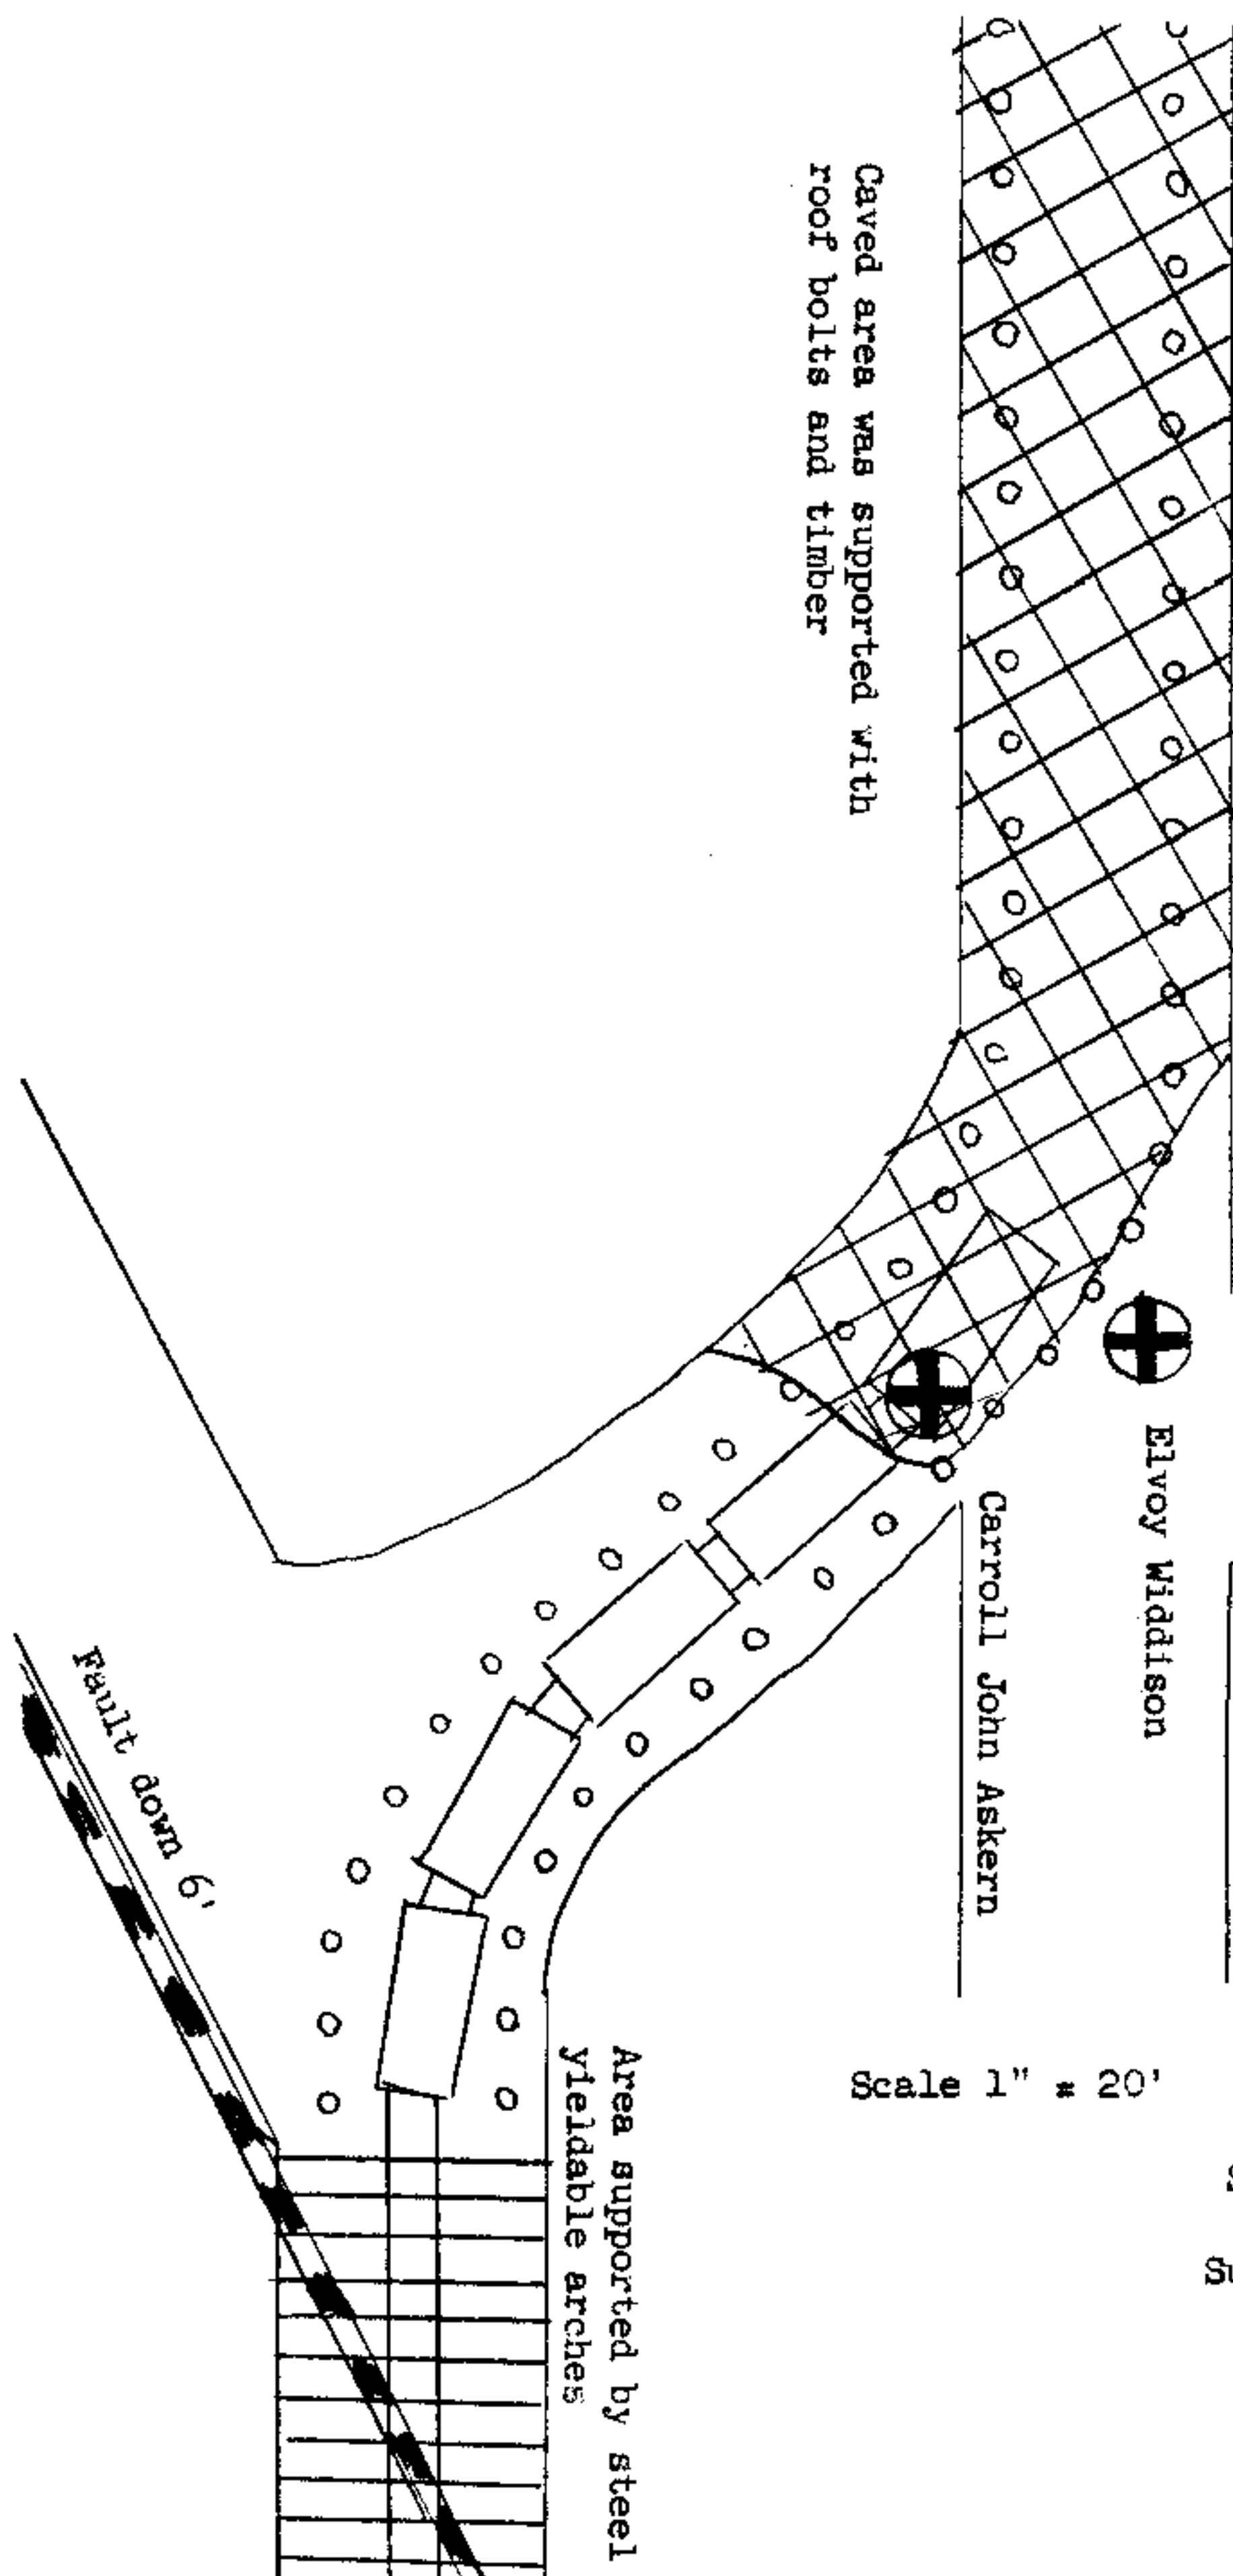
Scene of Bump occurring in 6th right,  
Sunnyside No. 2 mine, on Jan. 29, 1959,  
resulting in fatal injuries to Carroll  
John Askern

The fall of rock, about 100 feet long, 18 feet wide and 5 feet thick, pulled out some of the roof bolts and broke out from around others. The roof in the immediate area was supported by timbers up to 20 inches in diameter set about 8 feet apart along each rib and by 1-inch, wedge-type,

This accident was caused by a severe bump dislodging roof rock which was supported by large timbers and 1-inch, wedge-type roof bolts, 8 feet in length, installed 3 and 4 feet apart. Bumps of this type are one of the unsolved problems of coal mining; therefore, at this time there are no recommendations that can be offered to prevent accidents of a similar nature.
